INSTALLATION RESTORATION PROGRAM  
PRELIMINARY ASSESSMENT - RECORDS SEARCH FOR

147th FIGHTER INTERCEPTOR GROUP  
TEXAS AIR NATIONAL GUARD  
ELLINGTON FIELD AIR NATIONAL GUARD  
HOUSTON, TEXAS

November 1987

Hazardous Materials Technical Center  
The Dynamac Building  
11140 Rockville Pike  
Rockville, Maryland 20852

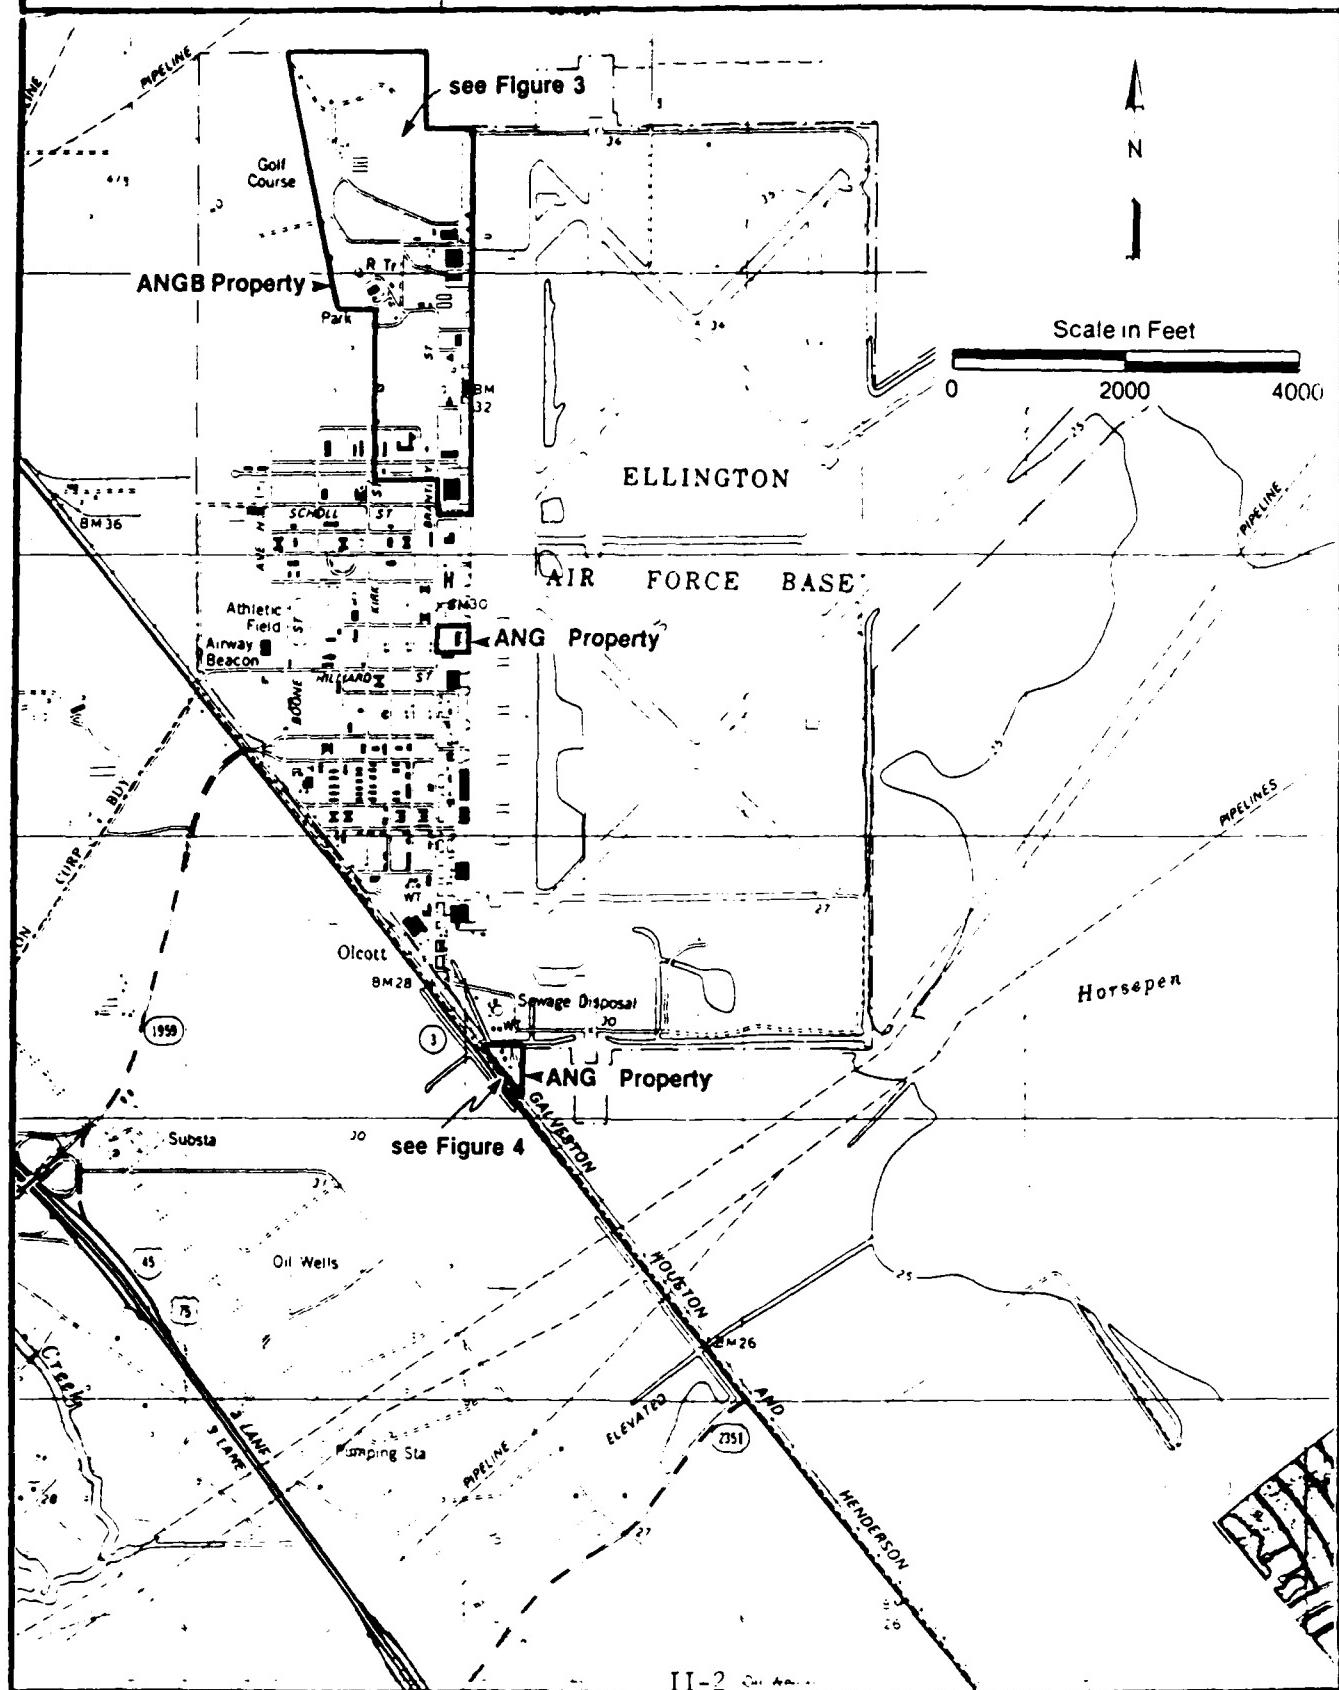
Figure 2.

This area is located on the north end of the Base off Greig Avenue behind Buildings 1356 and 1357 (Figures 2 & 3). It was a major area of concern during the Records Search. The landfill which is on Base property was used by the ANG until 1974 and many different wastes were buried there. After reviewing all information presented during the Records Search it was determined that there is no direct evidence of any HM/HW being disposed of at this landfill. For example, soil borings taken at this site show only areas of common refuse (see Appendix F). There were no areas of accumulated drums or containers which would appear to have contained HM/HW, and there were no indications of chemical odors. Based on information provided, a Hazard Assessment Score (HAS) cannot be determined. However, based on experience with similar types of municipal landfills on military installations, additional investigations at this site are warranted and should be undertaken.

This site is isolated from the main part of the Base and is located on the south end of Ellington Field off McLoughlin Avenue (Figures 2 & 4). The site is located within the POL storage and transfer area, which is surrounded by a chain link fence. The ANG property line is close to the fence. Two major JP-4 spills have occurred at this site. In 1973, an 8,000-gallon fuel spill occurred. Although attempts were made to contain the spill, most of the fuel reached an adjacent drainage ditch, which drains off ANG property. In October 1985, another JP-4 spill occurred in this same area. Although an estimated 5,000 gallons of fuel spilled, cleanup actions resulted in recovery of all but an estimated 200 gallons of fuel. Soil borings were taken in the POL storage area in September 1985. Although analysis for jet fuel indicated less than 500 ppm, soil boring results indicate strong "chemical odors" in two areas (see Appendix G for soil boring results). Because of the large volume of JP-4 spilled, observance of contaminated soil, chemical odor in the soil borings, and probable offbase migration of fuel because of close proximity of the property boundary, it was decided that a HAS and further study should be completed at this site.

This site is near the north end of the Base, off Wagner Avenue adjacent to the Fuel System Repair Shop (Figures 2 & 3). In November 1985, a waste fuel/oil leak occurred from an outside aboveground storage tank. The tank contained waste PD-680, JP-4, and water at the time. The spill area was contained with booms and the area flooded with water. The entire volume collected was pumped into a tank truck and transported to Building 1380 where it was transferred to an oil/water separator. Approximately 100 of the original 500 gallons spilled were recovered. The spilled material flowed across an asphalt road and continued onto a grassy area and then into a drainage ditch system. Vegetative damage and discolored soil was observed in the area during the site visit.
